#### Panther Service Bulletin – Mandatory

Aircraft: Panther LS and Panther Sport

**Bulletin Name: PSB5-M Flap Detent Mount Crack**

Regarding: Flap Detent Mount Bracket Reinforcement

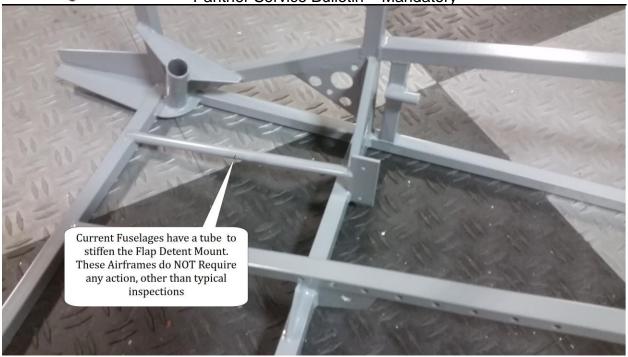
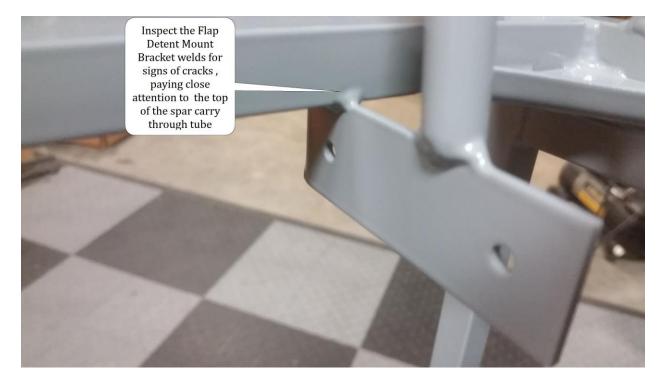
We have had one Panther LS powered by a Lycoming 0-320 develop a miniscule crack along the weld at the top of the flap detent mount.

Note: Later airframes have a brace tube installed to stiffen the detent plate mount bracket (see photo below). These airframes do not require any action other than normal preflight and condition inspections

Inspect the area identified in photos below for signs of cracks.

SPA LLC recommends installing a flap detent bracket reinforcement kit per drawings and instructions in kit.

Even if no crack is detected SPA LLC feels that the probability of an eventual crack is high enough to warrant a preventative measure.
